**RE: GEOTECHNICAL INVESTIGATION REPORT  
CONSTRUCT NEW SPECIALTY CARE (BUILDING 201B)  
DVA SOUTHERN OREGON REHABILITATION CENTER & CLINICS  
WHITE CITY, OREGON  
MAI JOB NO. 15-1017**

We are pleased to present our geotechnical investigation report for the proposed Specialty Care (Building 201B) project at the DVA Southern Oregon Rehabilitation Center & Clinics in White City, Oregon. The purpose of this investigation was to evaluate the subsurface conditions at the site and develop earthwork and foundation engineering recommendations for the project design. The proposed development is shown on Drawing 1, Site Plan.

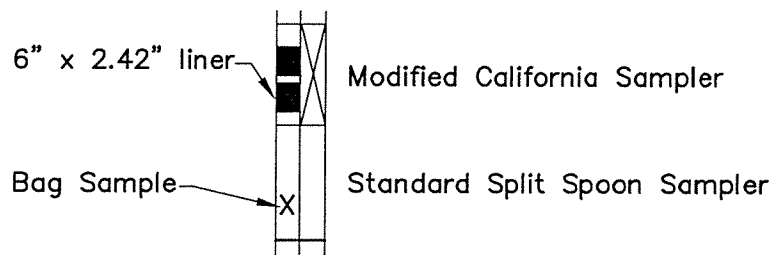
The standard penetration resistance blow counts were obtained in general accordance with the ASTM D1586 procedure by dropping a 140 pound hammer through a 30-inch free fall. The 2-inch O.D. split spoon sampler was driven 18 inches or to practical refusal and the number of blows were recorded for each 6-inch penetration interval. The blows per foot recorded on the boring logs represent the accumulated number of blows required to drive the penetration sampler the final 12 inches. In addition, 3.0 inch O.D. x 2.42 inch I.D. drive samples were obtained using a Modified California Sampler and a 140 pound hammer. Blow counts for the Modified California Sampler are shown converted to standard penetration resistance by multiplying by 0.6. The sample type is shown on the logs in accordance with the designation below.

Where obtained, the shear strength of the soil samples using either Torvane (TV) or Pocket Penetrometer (P) devices is shown on the boring logs in the far right hand column.
